BREMERTON GAS WORKS SUPERFUND SITE STATUS UPDATE

March 22, 2018

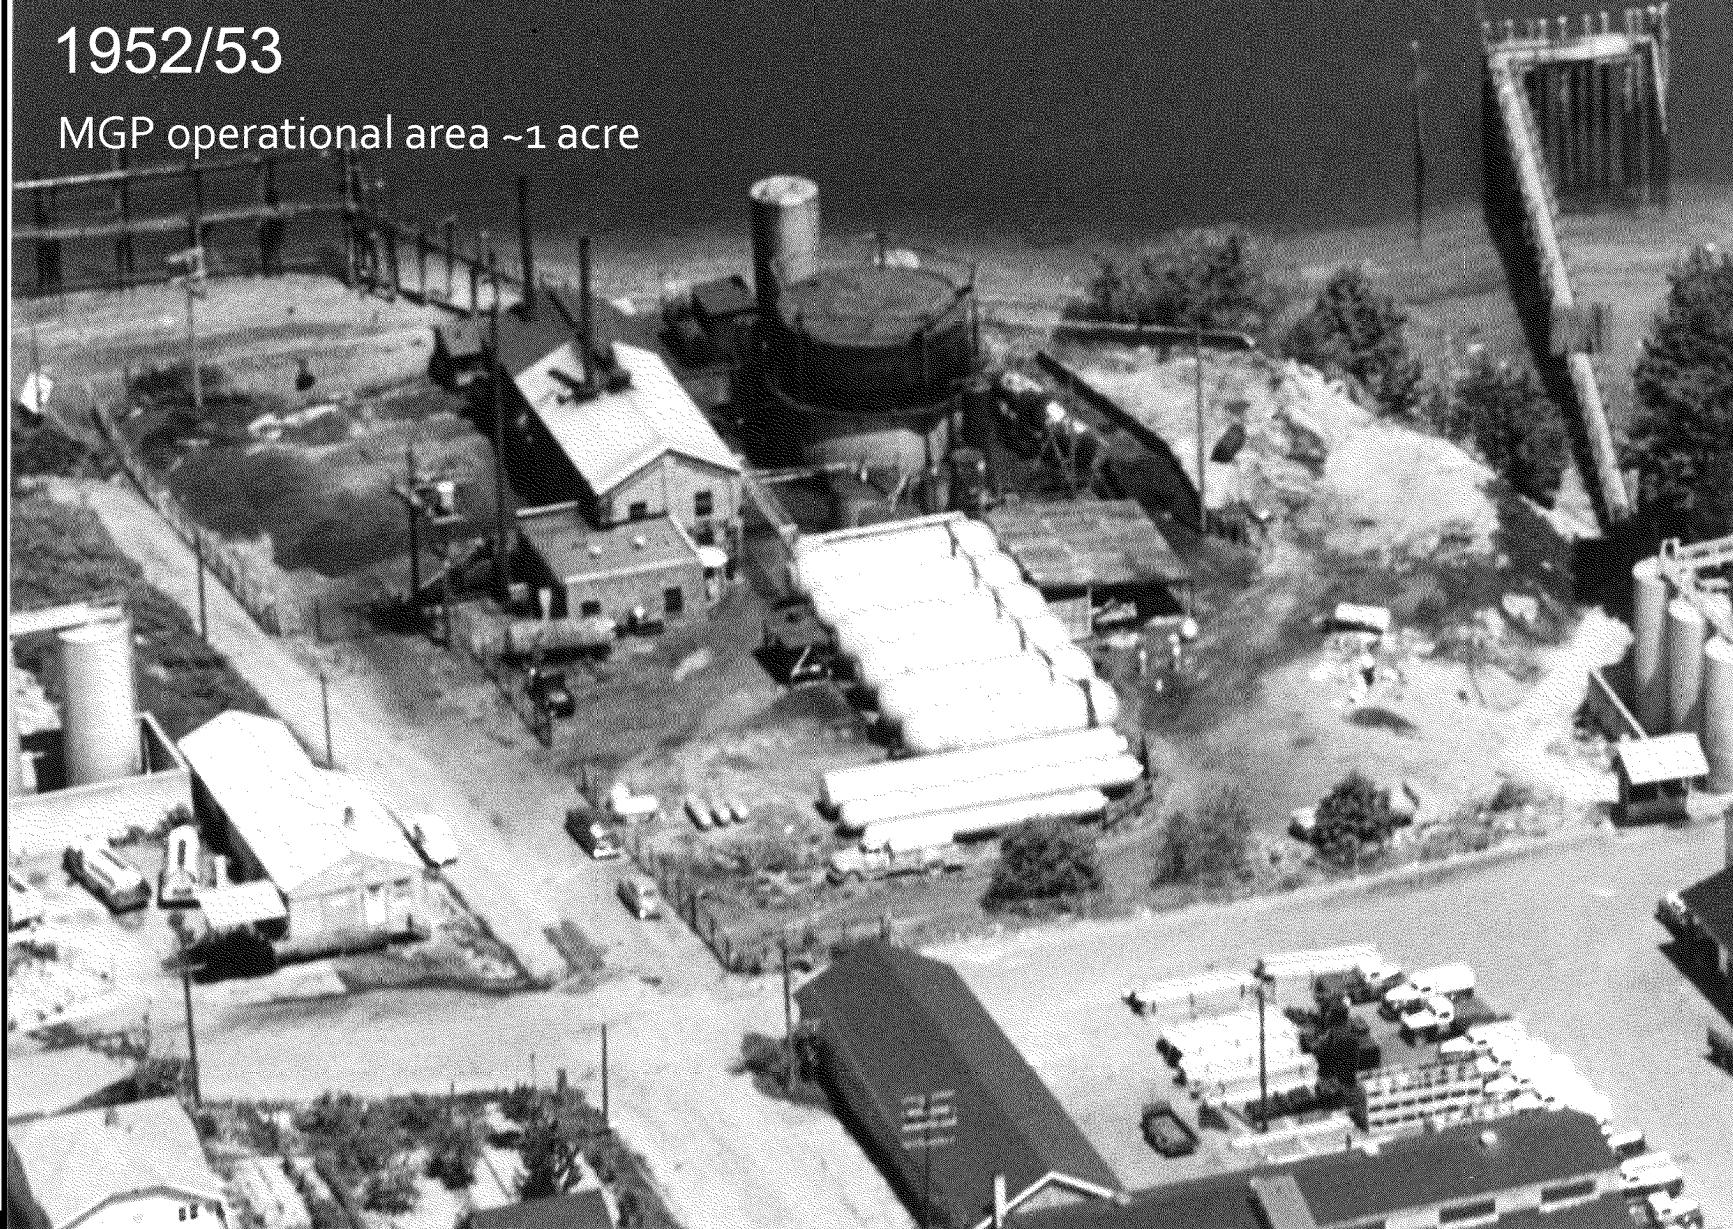
Bremerton Gas Works

1952/53

MGP operational area ~1 acre

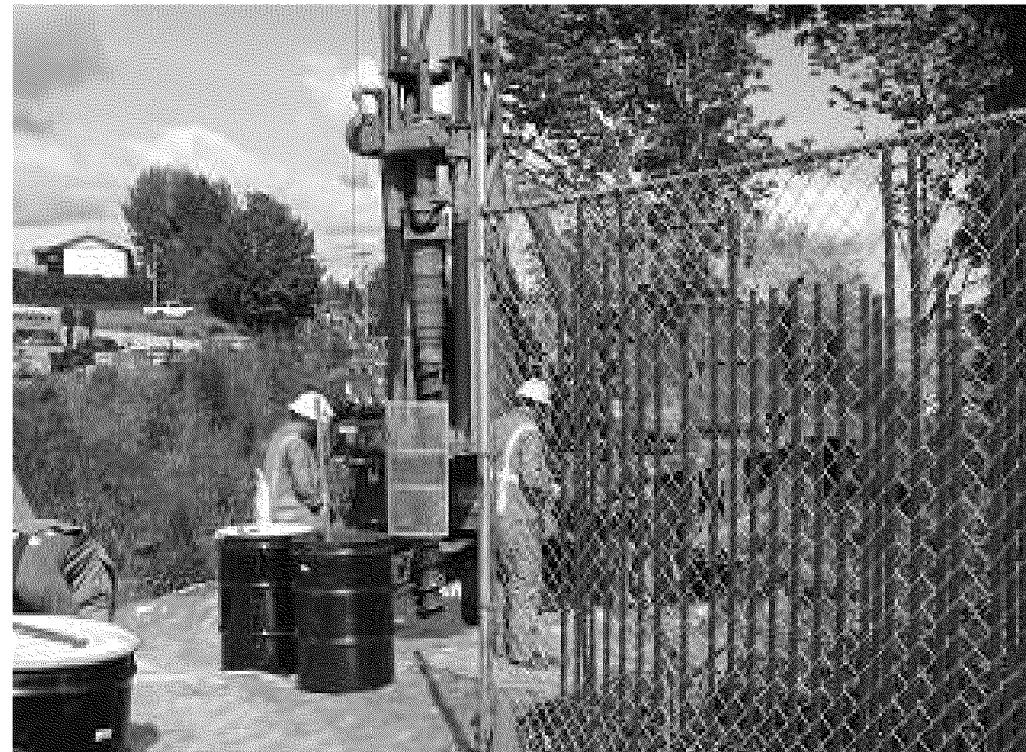
Previous Investigations

- 1995 – Ecology Field Inspection, Sesko Property
 - Analysis of three surface soil and one surface sediment sample
- 2007 – Preliminary Upland Assessment
 - 8 borings completed as monitoring wells
 - Analysis of soil and groundwater samples
- 2008 – Targeted Brownfield Assessment
 - 7 borings, 2 completed as monitoring wells
 - Analysis of soil, surface sediment and groundwater samples

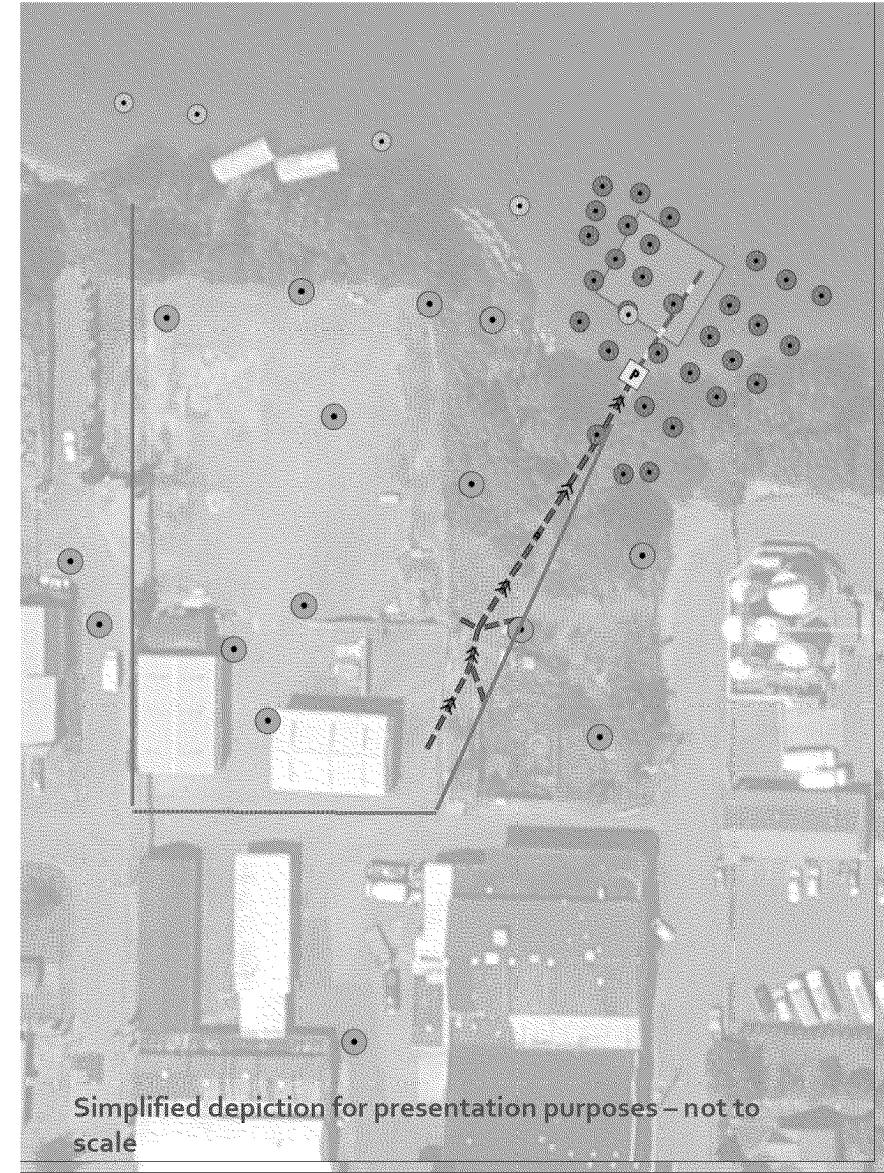
Time Critical Removal Action (2010 TRCA)

- Former Drainage Line cut and plugged
- Mat placement

- Soil and Groundwater
- Explorations
- Ecology and Environment (2009)
- Ecology and Environment (2010)

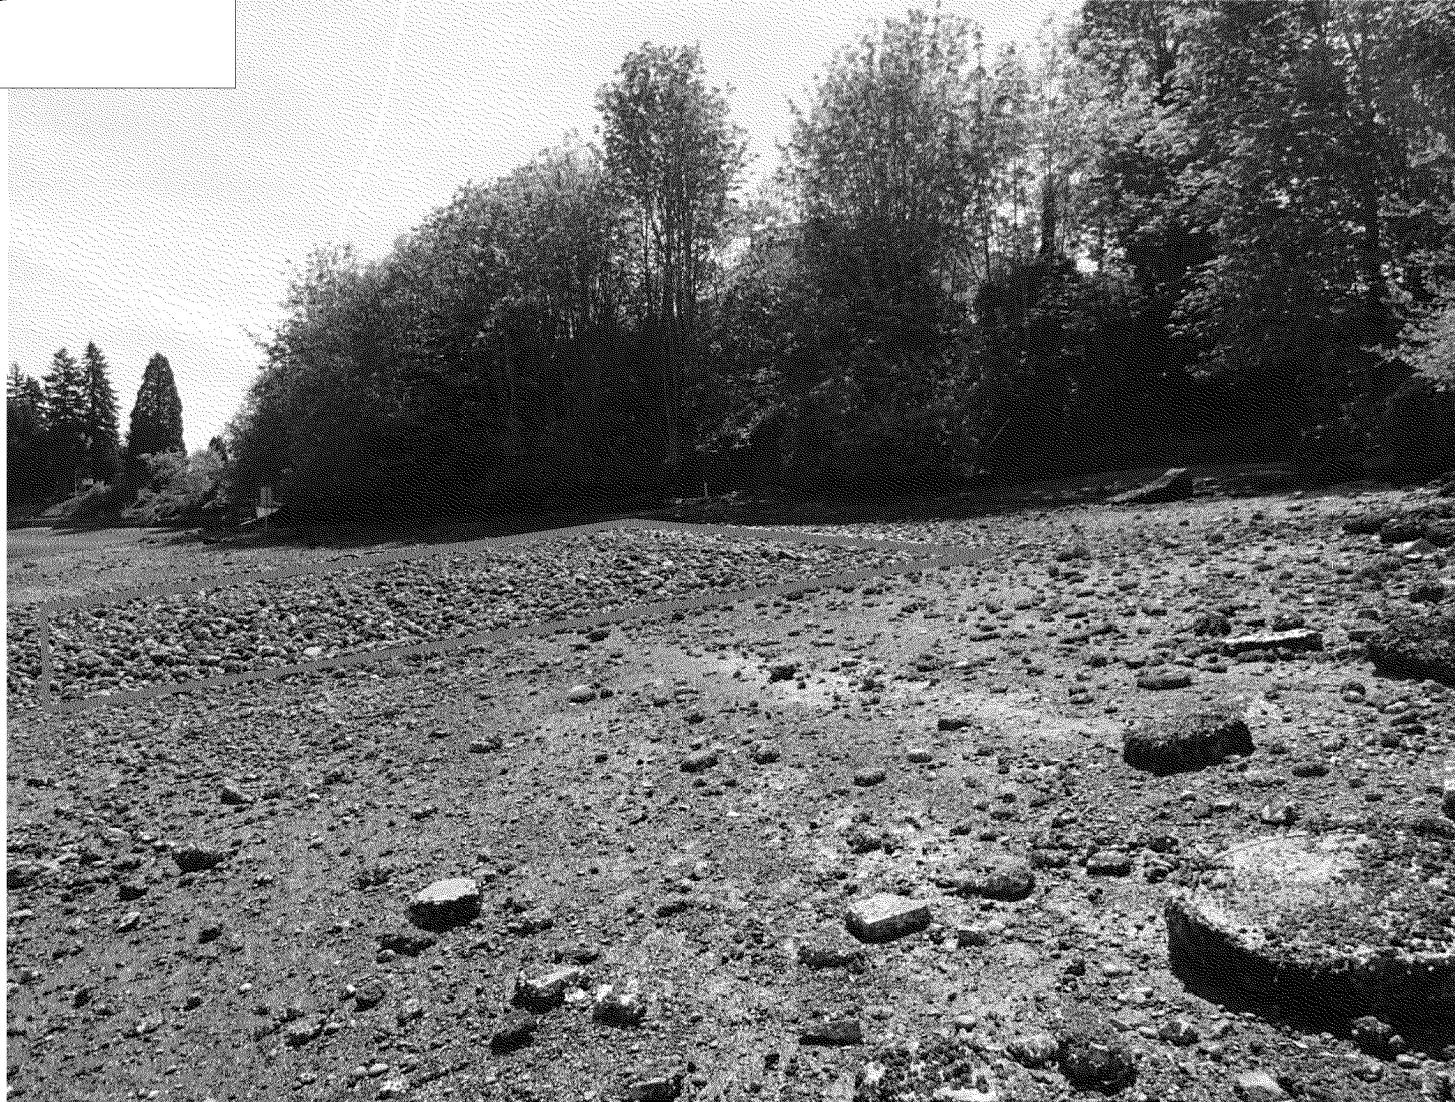
2010 TCRA

Actions Taken

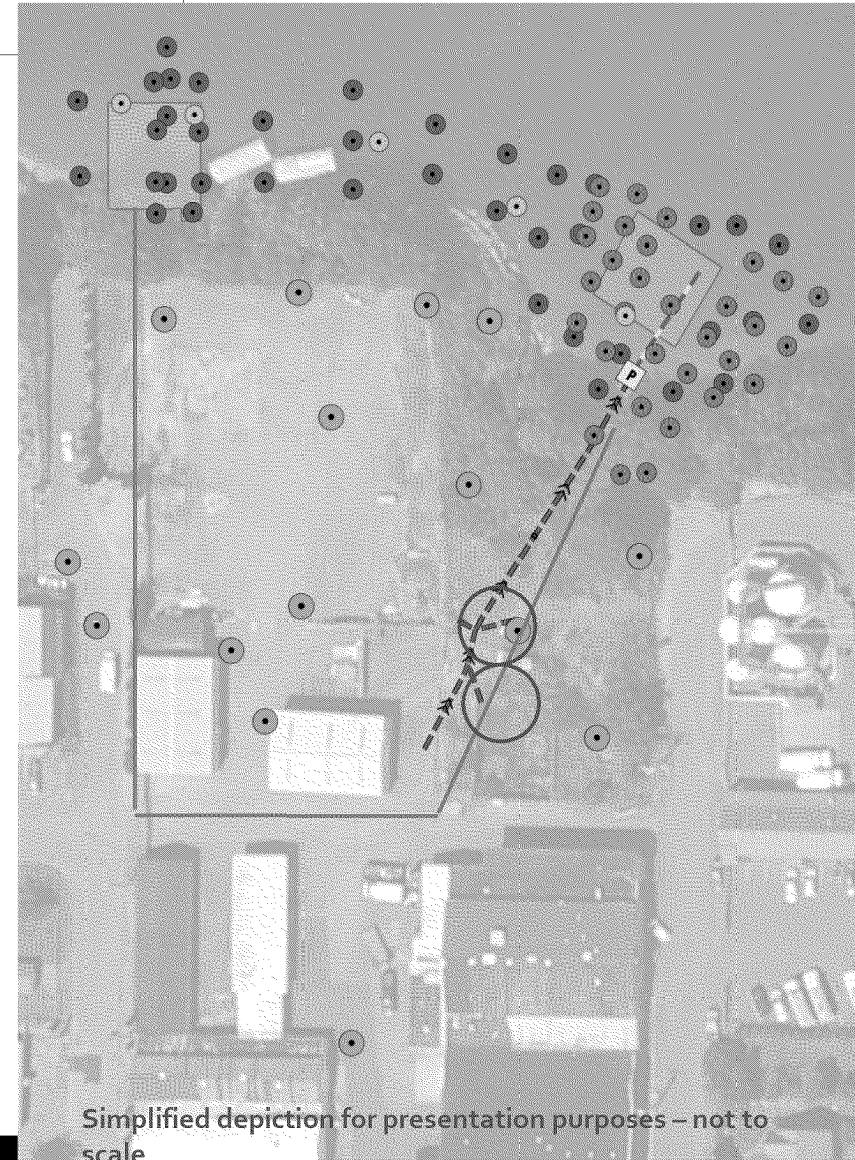
2013 Time Critical Removal Action (2013 TCRA)

- Placing 2nd mat
- Capping of Manhole A
- Plugging the drain

- Soil and Groundwater Explorations
- Ecology and Environment (2009)
- Ecology and Environment (2010)
- Anchor QEA (2013)

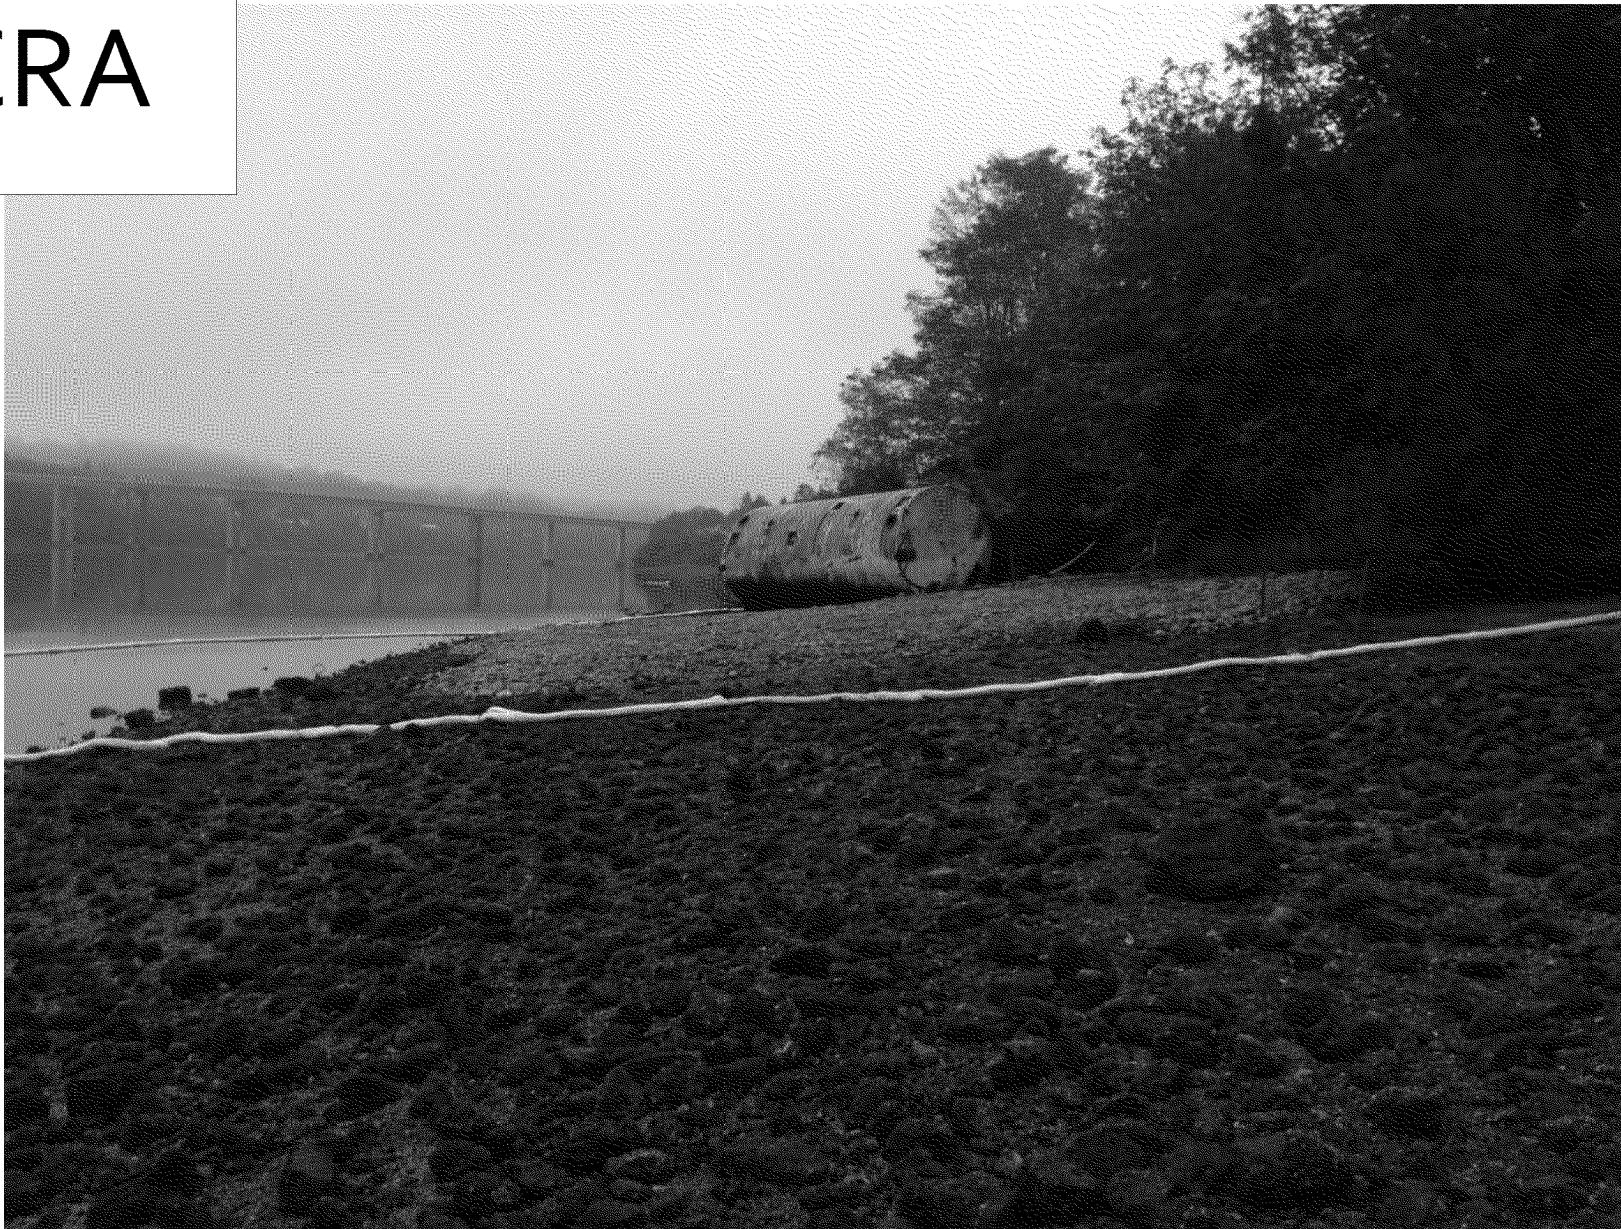
2013 TCRA

Actions Taken

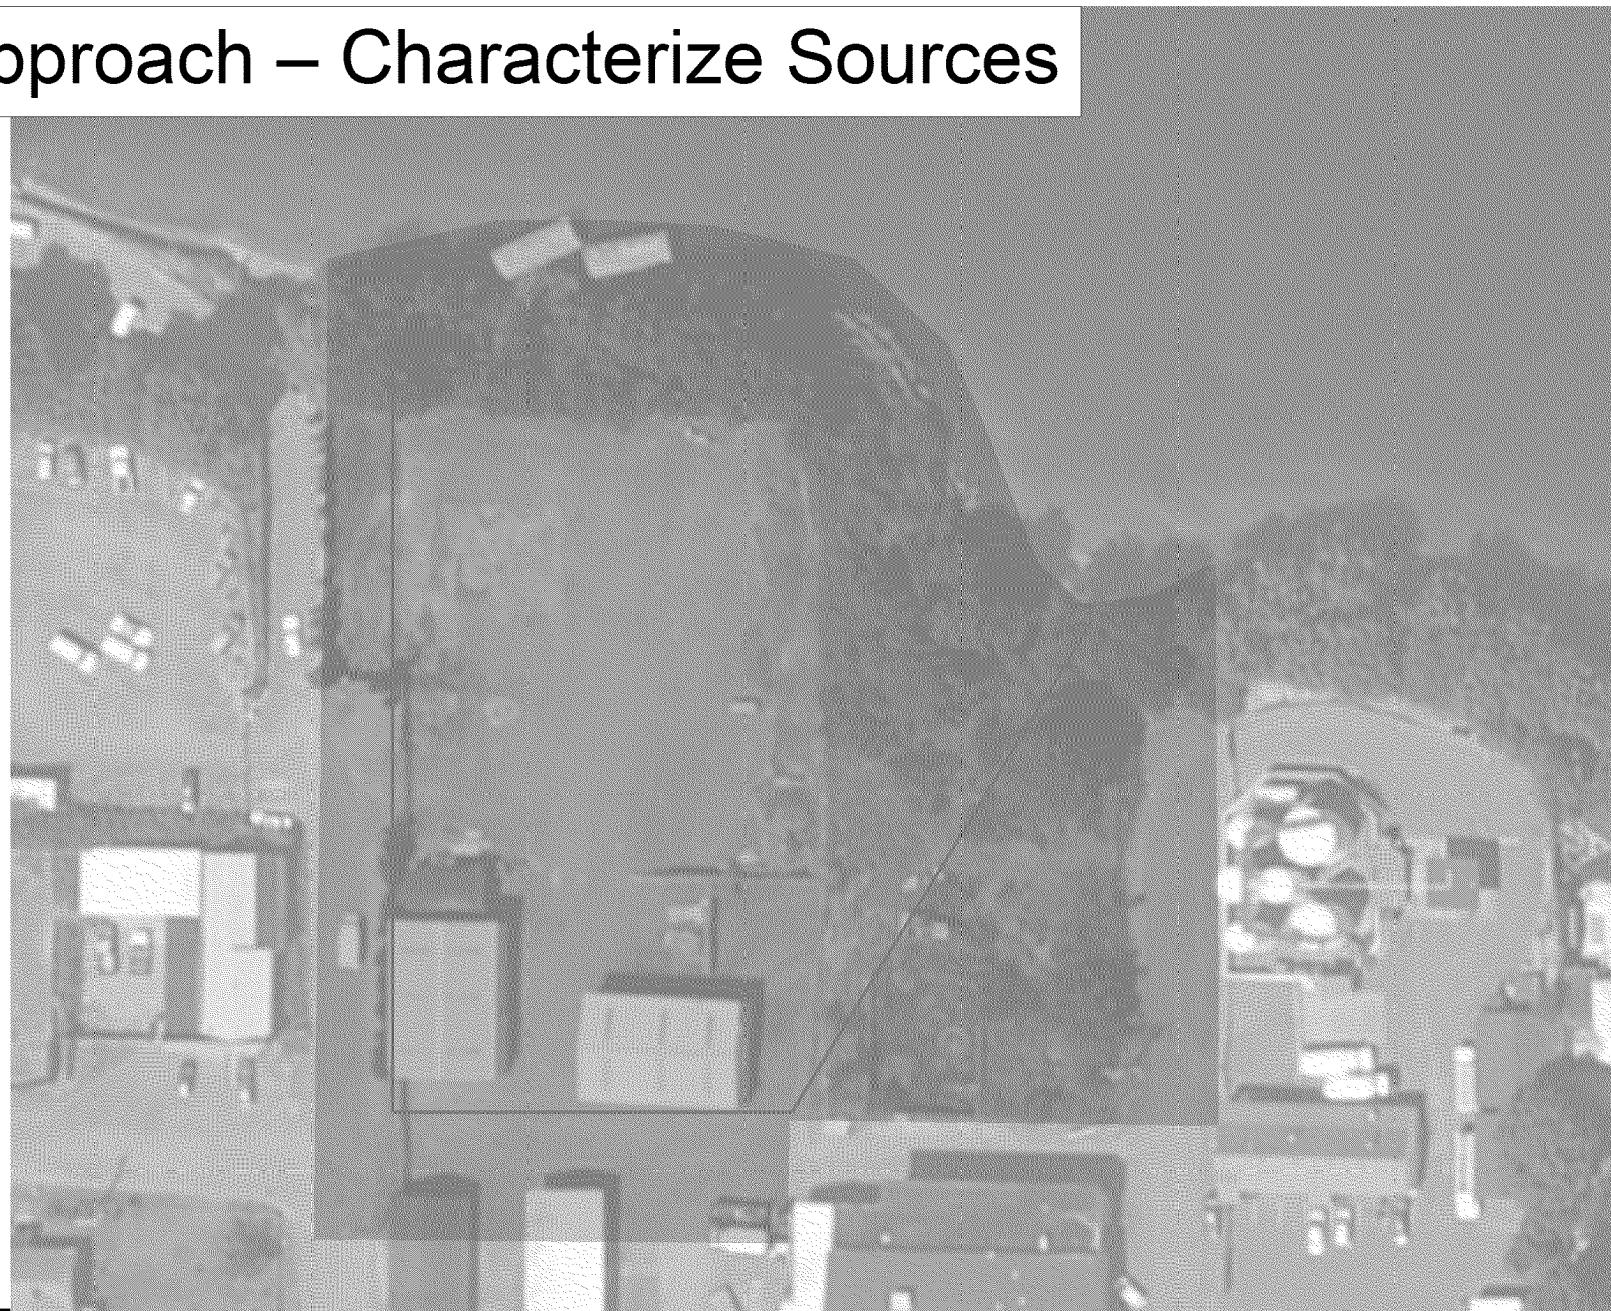
Upland Investigation Approach – Characterize Sources

Surface explorations:

- Geophysics, utility location and survey

Source investigation:

- Trenches/cross-trenches for lateral limits
- Borings for vertical limits

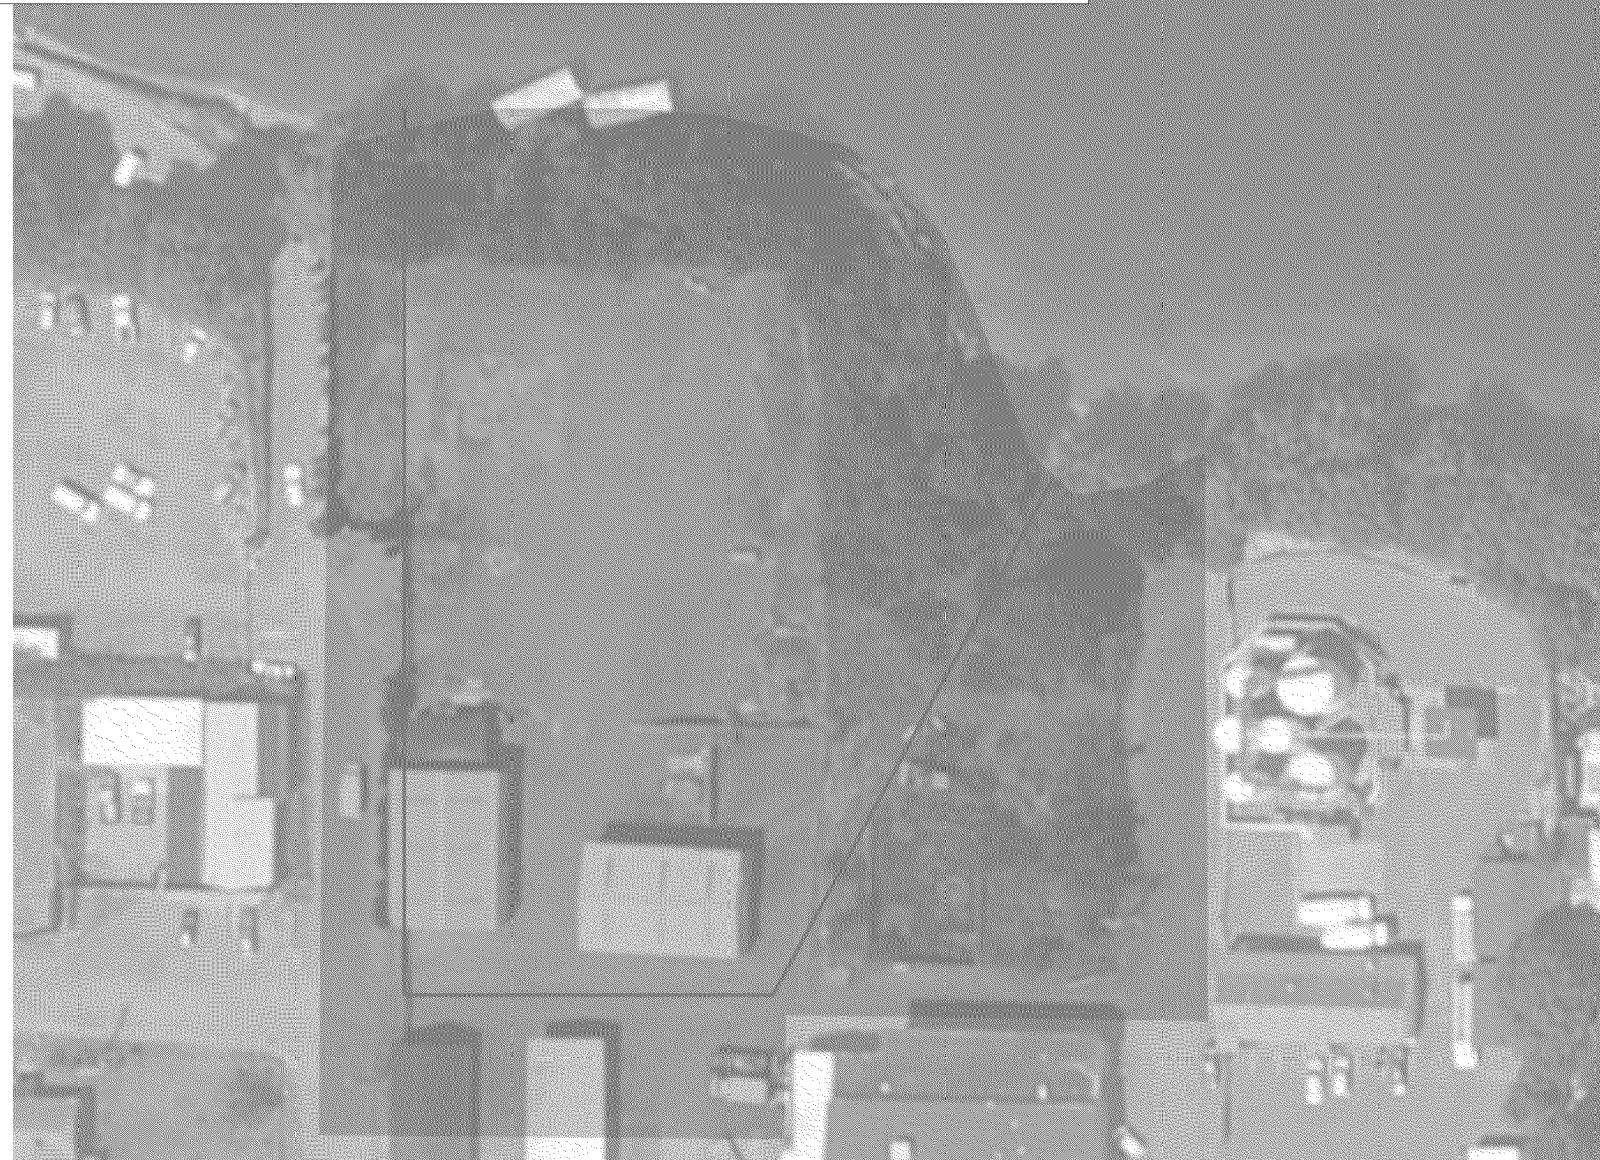
Upland Investigation Approach – Outside Source Areas

Deep investigation for hydrogeologic CSM

- Deep borings/wells for lithology, groundwater flow
- Downgradient of Source Areas: boring transects to locate monitoring wells
- Lateral limits of contamination:
 - ISM sampling and/or soil borings
 - 'Boundary' monitoring wells

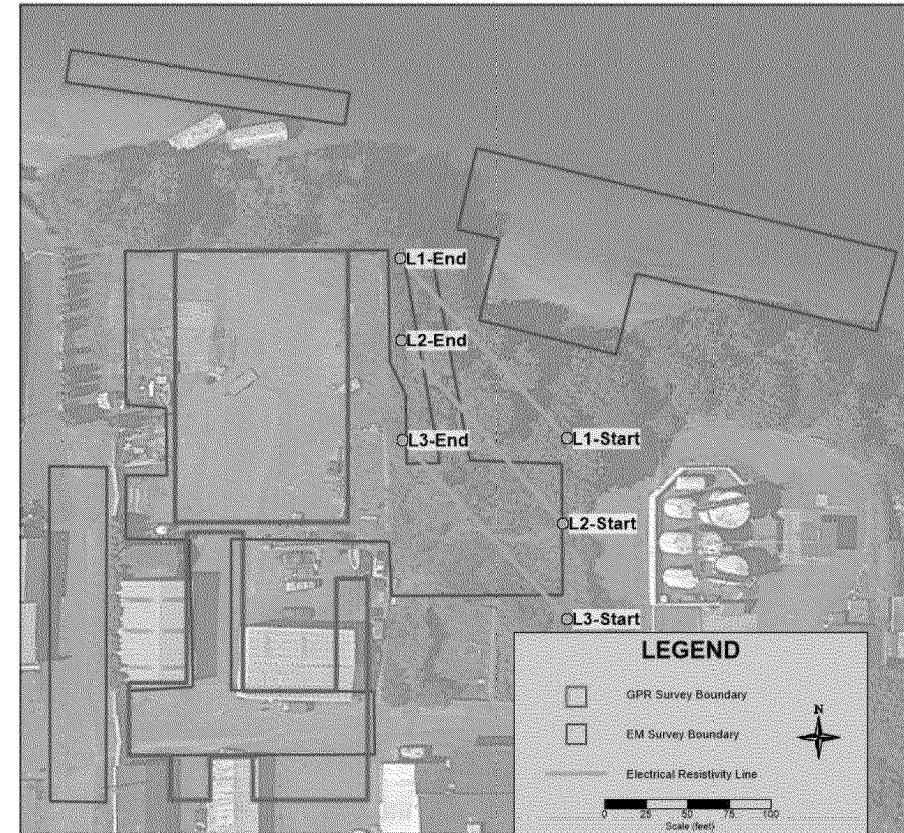
Geophysical Survey Areas

- Ground Penetrating Radar (GPR) and Electromagnetic (EM) surveys: detect subsurface anomalies
- Electrical Resistivity (ER) survey: depth of fill in former ravine

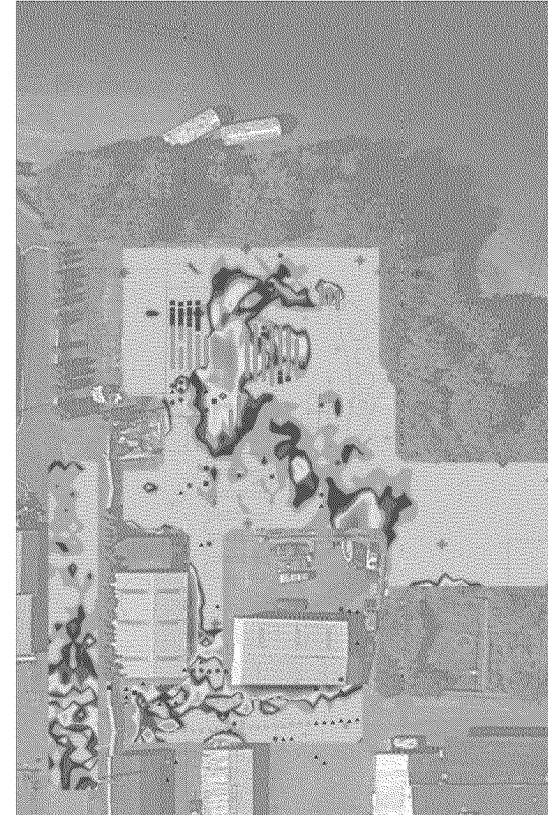
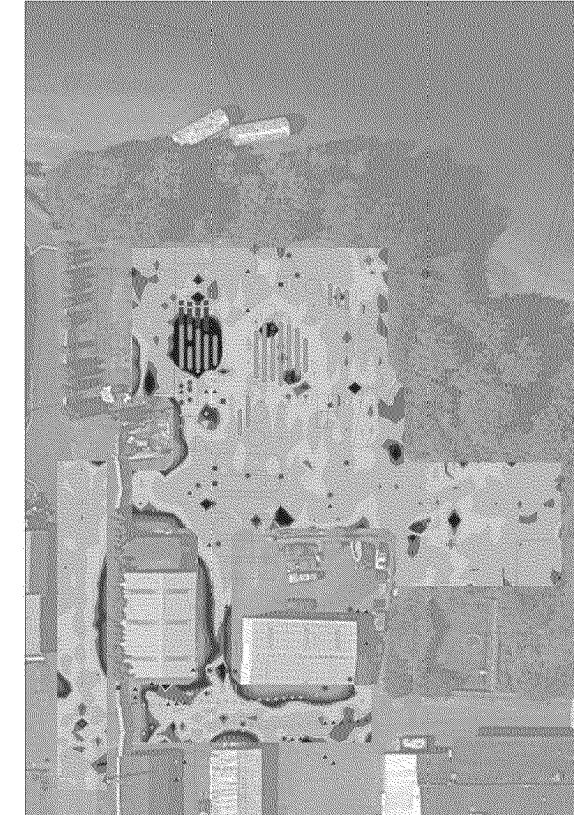
Geophysical Surveys – GPR/EM Results

- Many anomalies consistent with utilities and former structure/tank foundation locations
- Some trench locations added or adjusted to match identified anomalies

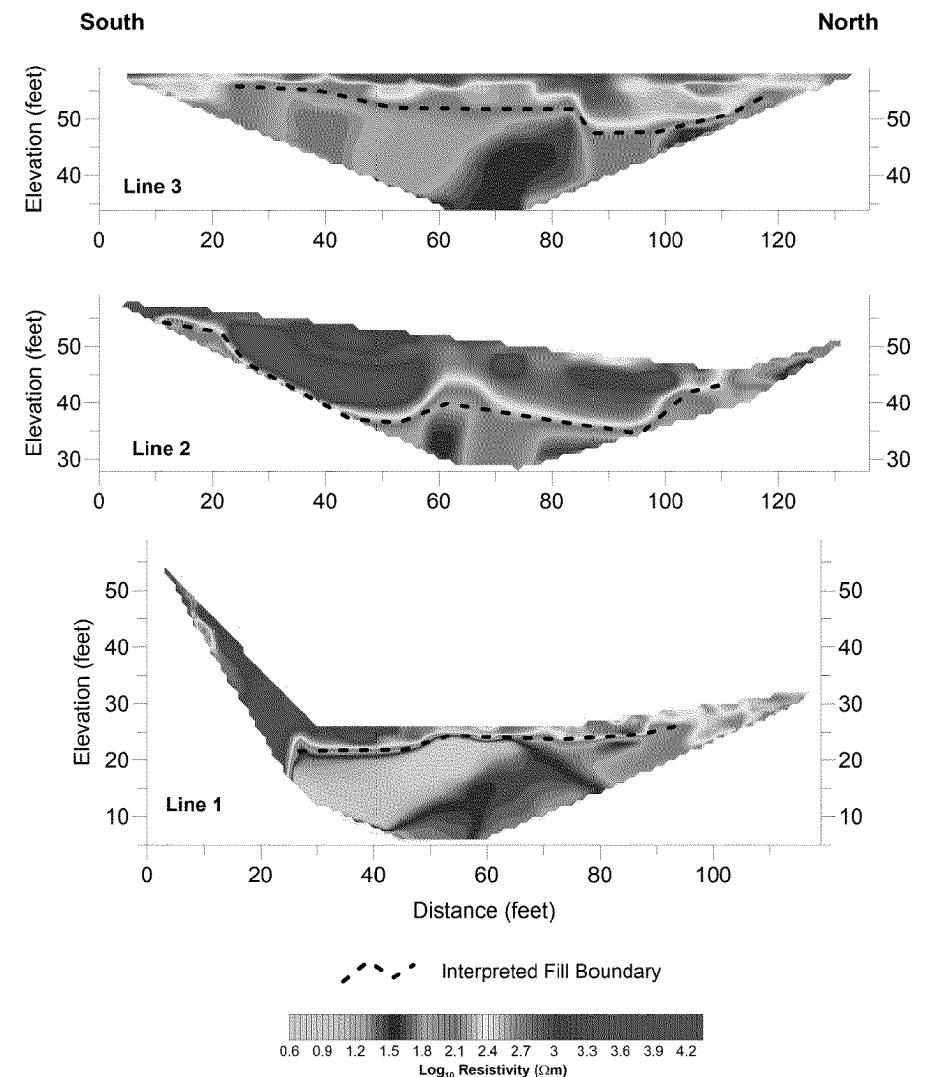
Geophysical Surveys – Electrical Resistivity Results

- Estimated depth of fill - up to ~15'

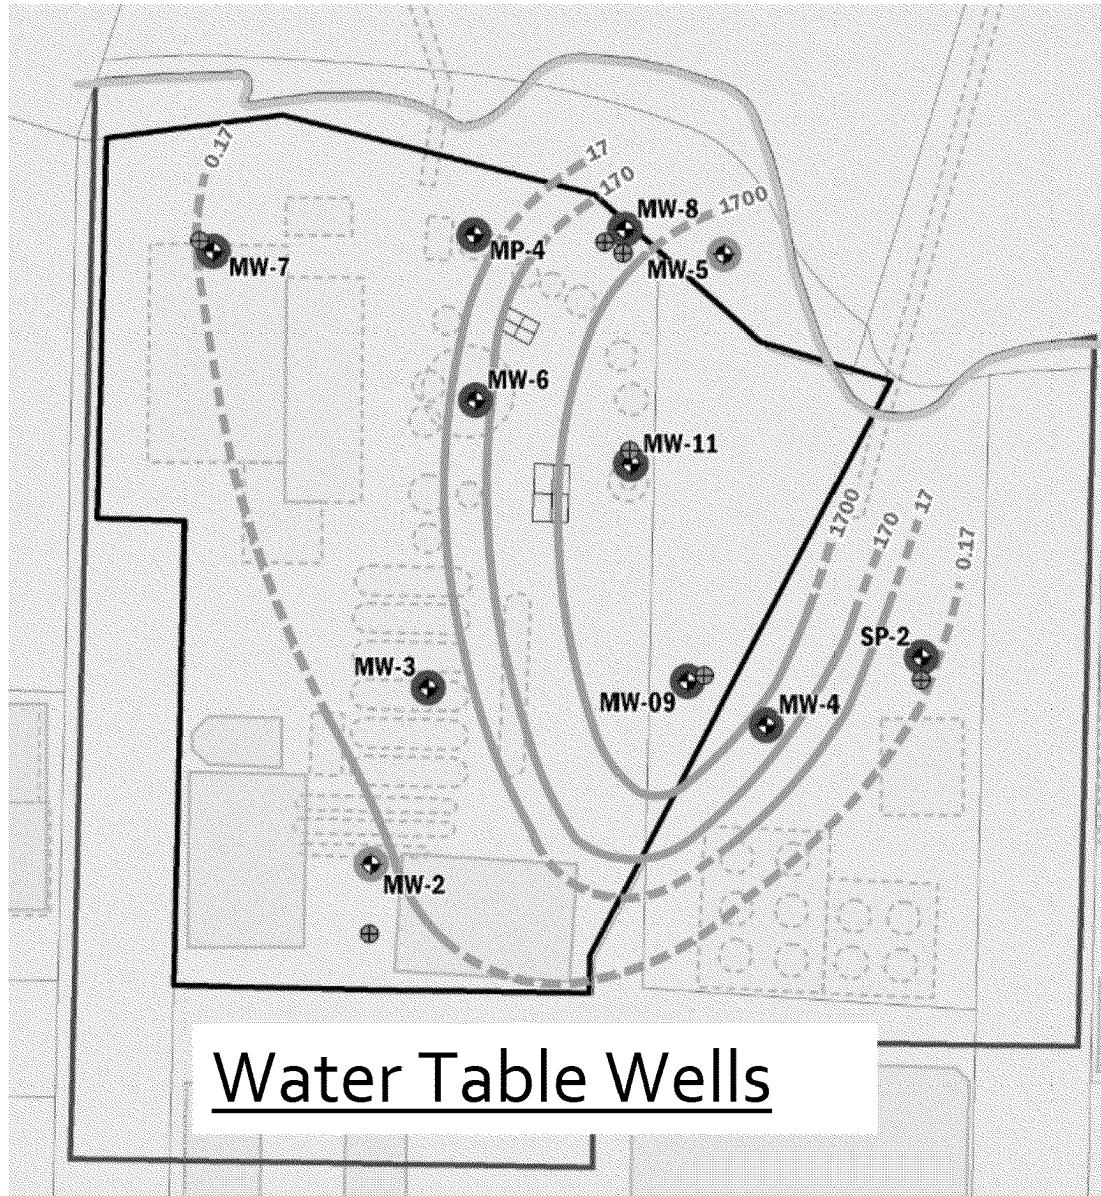
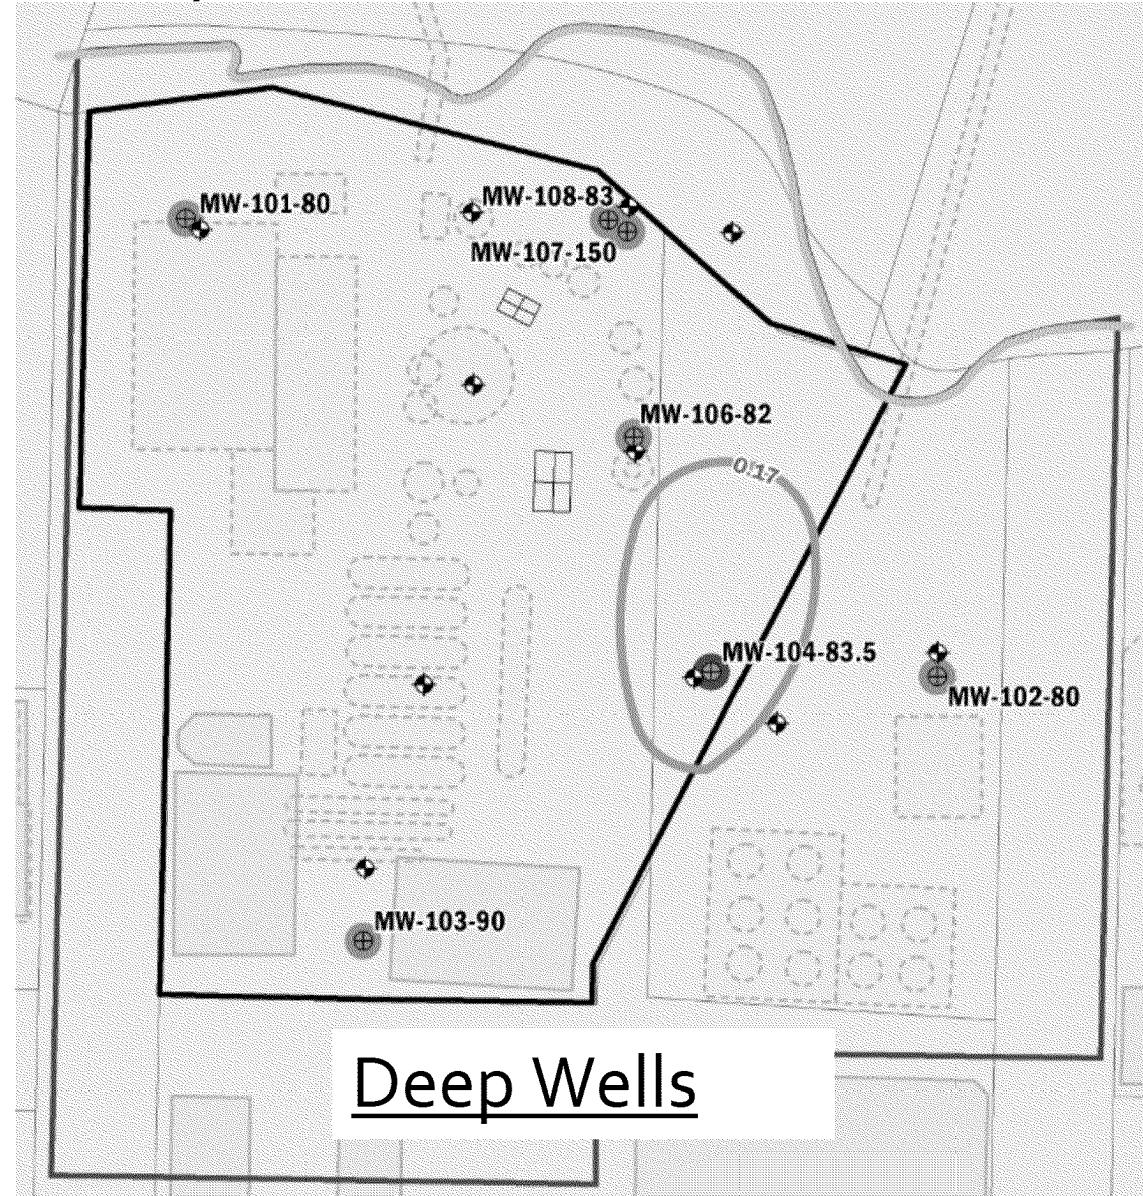
Source Investigation Groundwater Data - Naphthalene

- Source Materials Identified:
 - Boiler ash and spent purifier media (wood chips) in former ravine fill.
 - NAPL in and beneath former ravine fill – maximum depth 34 feet.
 - NAPL stringers in shallow soil in southwest corner.
- Primary constituents of concern: PAHs, BTEX and cyanide.
- Groundwater ~30 feet deep, in Advance Outwash (dense sand/silty sand).
- The Advance Outwash extends to >200 feet bgs (maximum depth explored).
- Maximum depth of soil and groundwater contamination ~90 feet.

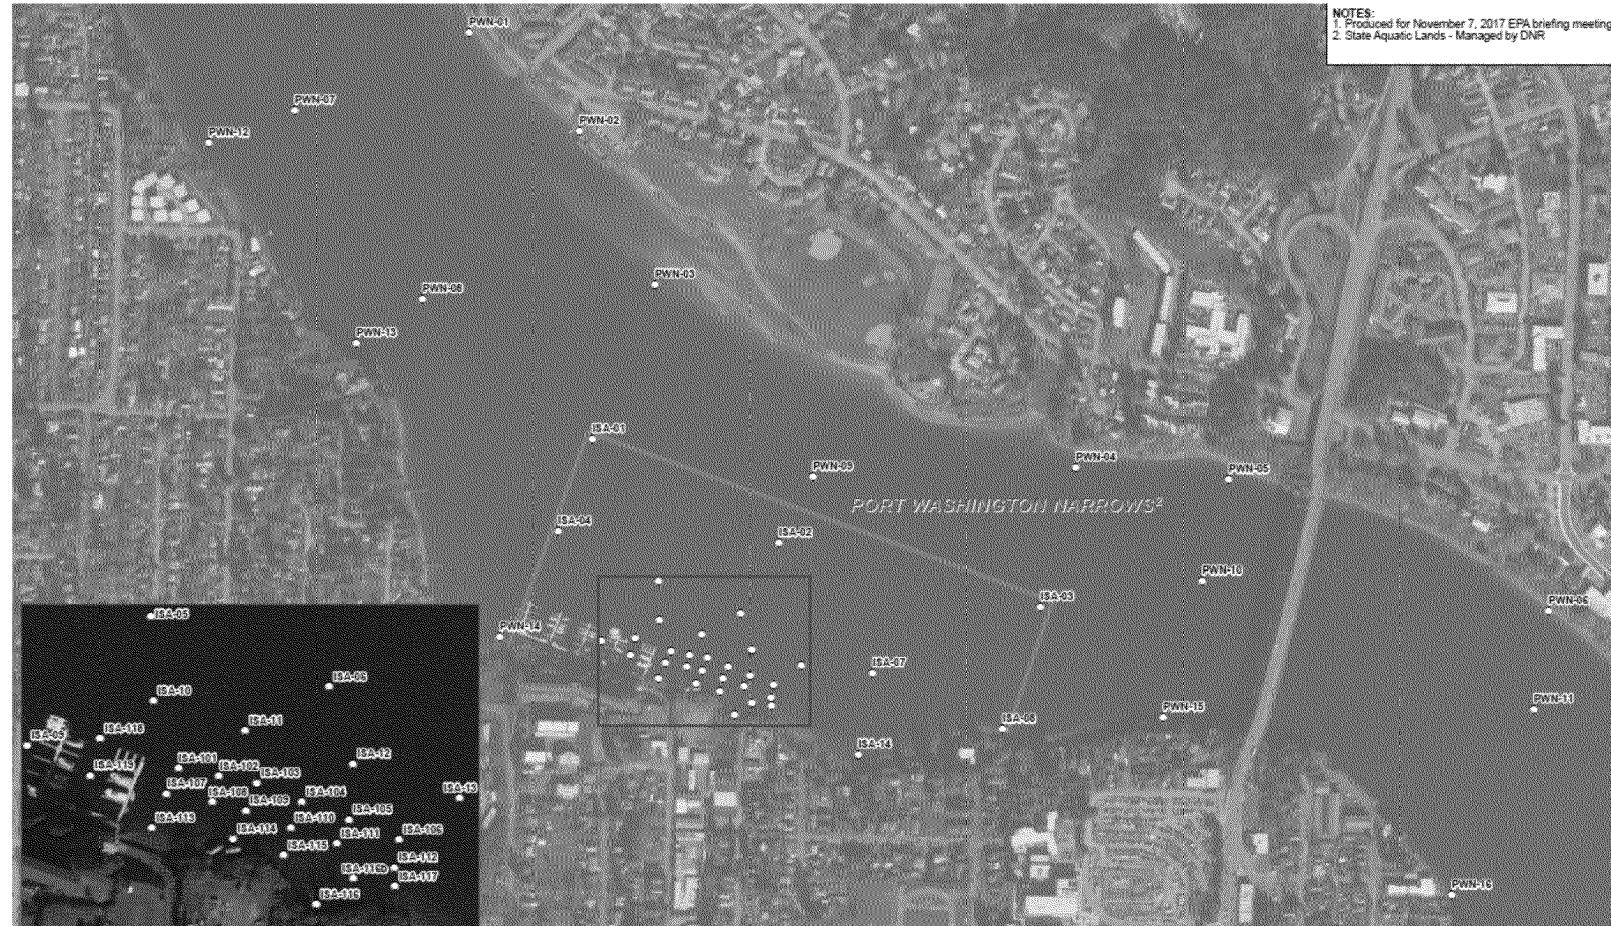
Marine Investigation Areas

- Initial Study Area (ISA)
 - Physical, habitat, and chemical evaluations
- Port Washington Narrows (PWN)
 - Sediment physical testing to evaluate sediment transport
 - Surface water chemistry

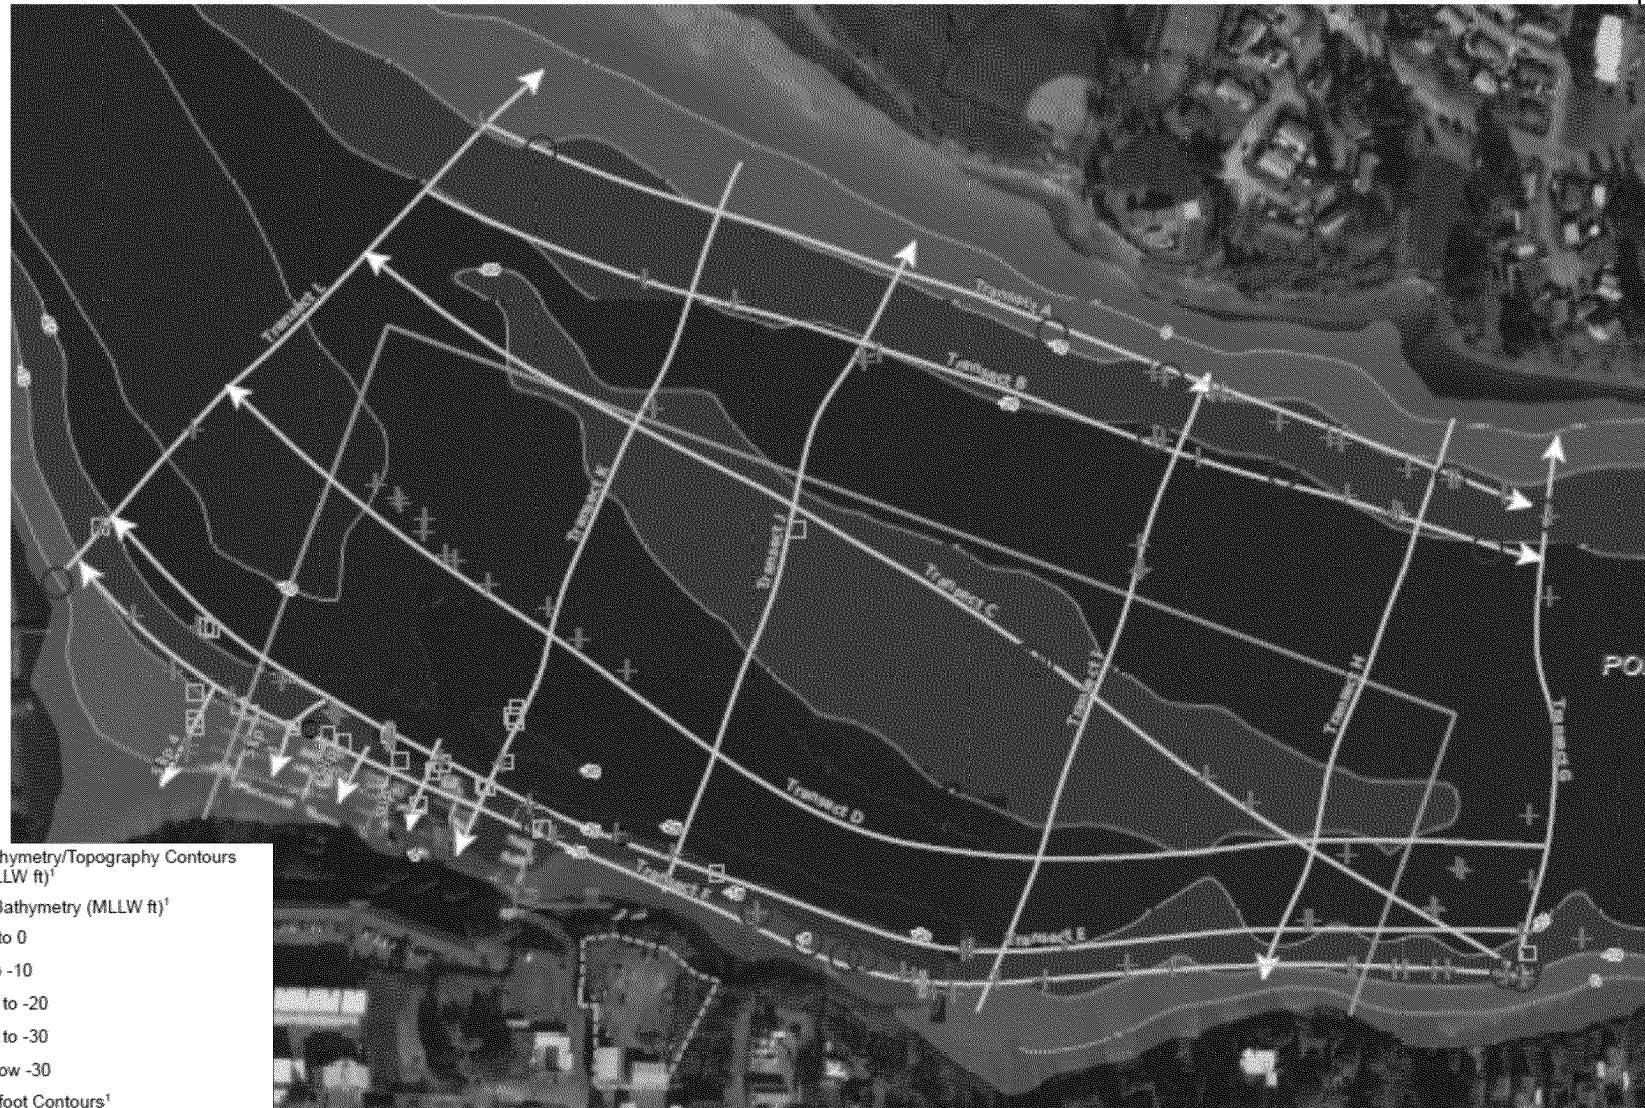
Marine Investigation Surveys

- Physical Surveys
Conducted Summer
2017
 - Video transects
 - Shellfish transects
 - Current velocity
profiles

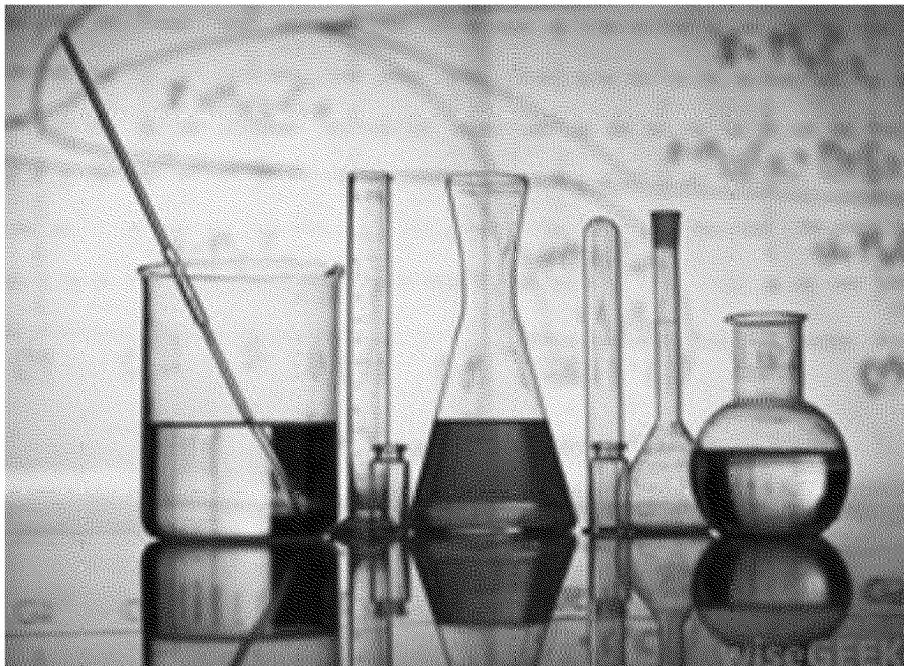
Surface Sediment PAH Results

- Initial evaluations suggest PAHs are the most significant chemical class within the ISA, as anticipated
